GREENHAVEN CORRECTION FACILITY DAM

**DUTCHESS COUNTY, NEW YORK
INVENTORY NO. N.Y. 1170**

**PHASE I INSPECTION REPORT
NATIONAL DAM SAFETY PROGRAM**

SEPTEMBER 1981

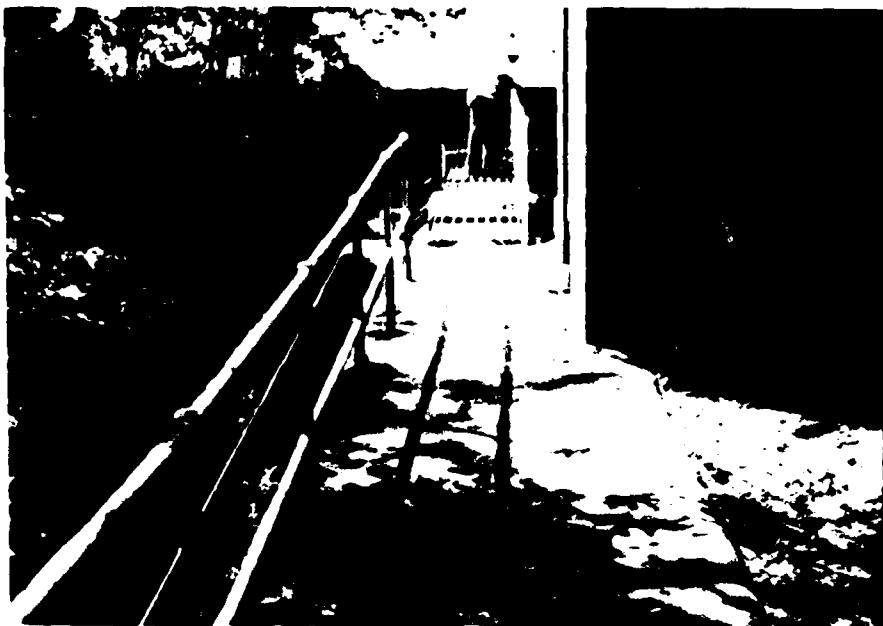
2) CENTERLINE VIEW OF DAM FROM LEFT ABUTMENT
(NOTE UPPER LEVEL SPILLWAY CHUTE ON RIGHT
ABUTMENT)
